# *END CAP INSPECTION GUIDE*

*A guide for the Inspection and/or Replacement of  
End Caps on SCI Non Limited Life Composite Cylinders*

**TP-902.08/A**

**Structural Composites Industries, LLC**

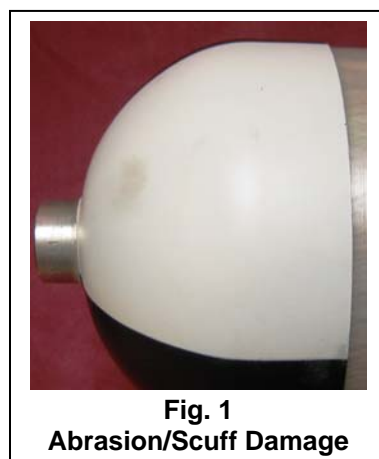
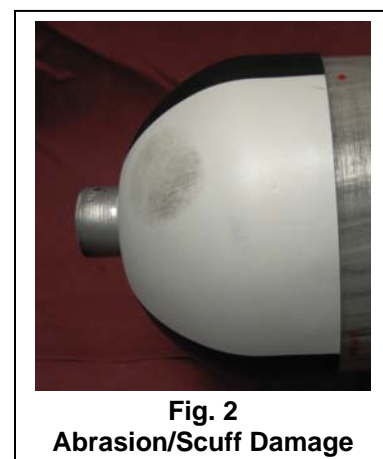
- Scuffs are minor abrasion damage to the protective coating (i.e. paint). Examples are shown in Fig. 1 and Fig. 2 below.

**Level 1** - Minor abrasions in the shoulder area such as scuffs less than 0.12 in (3 mm) deep are acceptable. Where painted areas are scuffed, touch up or rework is allowed. Refer back to Fig. 1 and Fig. 2 for examples of acceptable Level 1 abrasion damage.

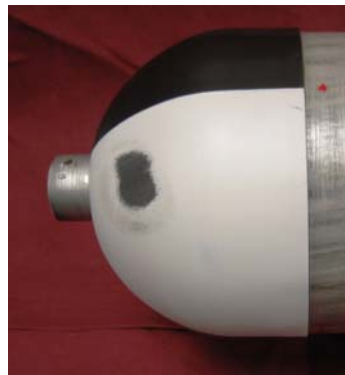
**Fig. 3  
Abrasion Damage**

- Abrasion involves a greater loss of surface than scuffs with more raw foam showing. These can be caused by sliding contact with a rough surface. Excessive rough spots and flat spots on the surface are evident of excessive loss of foam thickness. An example is shown in Fig. 3 below.

**Level 2** - Abrasions and flat spots in the shoulder area exceeding a depth of 0.12 in (3 mm) are unacceptable. Caps with this level of damage shall be replaced. Refer back to Fig. 3 for an example of unacceptable Level 2 abrasion damage.

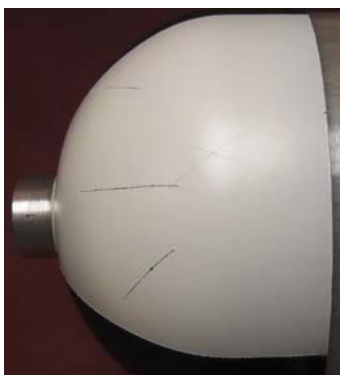
**Fig. 4  
Cut Damage**

**Level 1** - Cuts or scratches in the shoulder area less than 0.20 in (5 mm) deep are acceptable. The number of scratches with depths of 0.20 in (5 mm) shall not exceed 3 per quadrant, regardless of direction, with a maximum length of 1.50 in (38 mm). Refer back to Fig. 4 and Fig. 5 for examples of acceptable Level 1 cut damage.

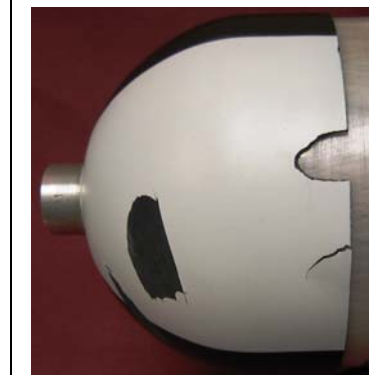
**Fig. 6  
Tear Damage**

- Tears are usually separations caused by excessive force by pulling or ripping. Examples of cuts and tears are shown in Fig. 4, Fig. 5, and Fig. 6 below.

Torn caps are acceptable provided tears are not in the shoulder area. Refer back to Fig. 6 for an example of acceptable Level 1 tear damage.

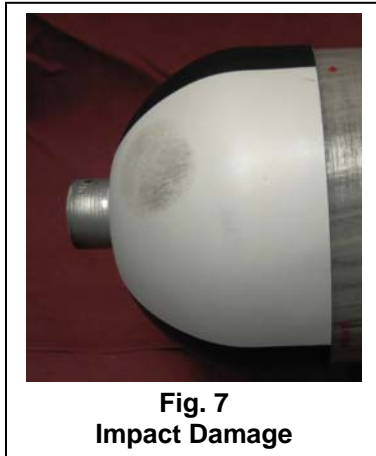
This type of damage is caused by dropping or by a blow from a blunt instrument and may appear as crazing, permanent dent, or deformation and sometimes a tear. Examples are shown in Fig. 7 and Fig. 8 below.

**Level 1** - The foam dome caps are very resistant to this type of damage and a significant impact is required to cause damage sufficient to warrant replacement. Damage which is relatively slight, from normal use, will show nothing or a very light scuff mark in the impact area and the cylinder may be returned to service. Refer back to Fig. 7 for an example of acceptable impact damage.

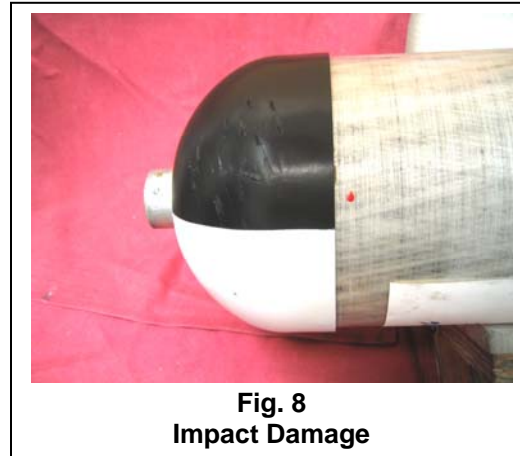
**Level 2** - Damage is severe if structural damage is present. Refer back to Fig. 8 for an example of unacceptable impact damage.

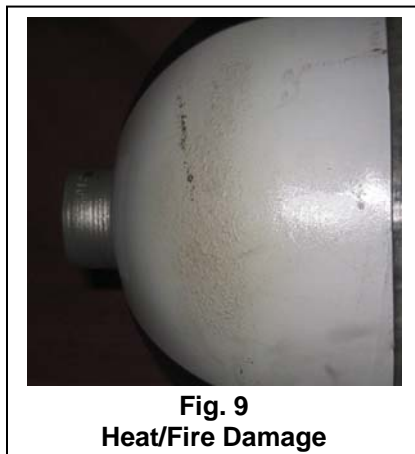
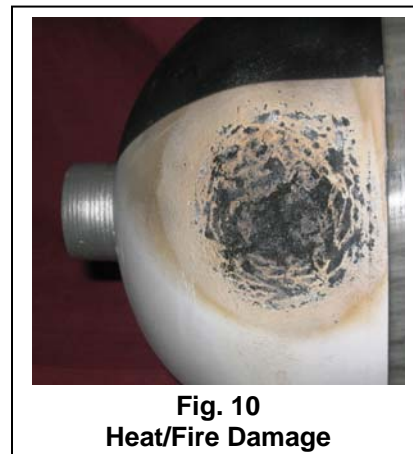
Heat or fire damage is evident by discoloration, charring, or melting of the foam. Examples are shown in Fig. 9 and Fig. 10 below.

**Level 2** - Caps with signs of heat or fire damage (charring, melting, or bubbling) are considered to be unacceptable and must be replaced. If the cylinder is thought to have been exposed to excessive temperatures, then it should be taken out of service and retested. Refer back to Fig. 9 and Fig. 10 for examples of unacceptable heat/fire damage
