# *END CAP INSPECTION GUIDE*

*A guide for the Inspection and/or Replacement of  
End Caps on SCI Non Limited Life Composite Cylinders*

**TP-902.08/A**

**Structural Composites Industries, LLC**

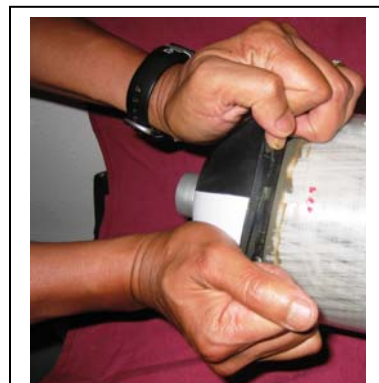
**Fig. 11**  
**Cap Removal**

- Secure the composite cylinder body using an appropriate fixture, as it very important not to damage the cylinder.
- Remove the end cap by forcibly peeling back the foam cap with both hands (see Fig. 11 below). A careful cut with a sharp hook razor blade may be used for ease of removal, taking care not to cut the composite.

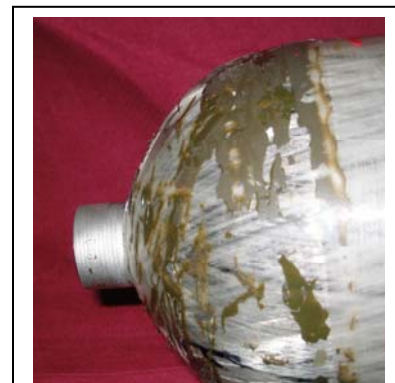
**Fig. 12**  
**Cap Removed**

- After end cap removal, wipe dome with acetone or alcohol. Do not attempt to remove the remaining adhesive that adhered to the dome (see Fig. 12 on previous page).

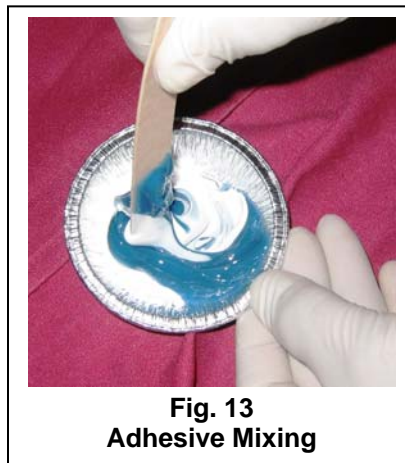
- Mix a small equal amount of part A and part B adhesive (see Materials and Equipment section) in a clean container. Mix quickly and thoroughly; until the blue and white colors turn a uniform light blue color (see Fig. 13 below). The adhesive sets very quickly (approximately 5 to 6 minutes), so it is important that everything is prepared.

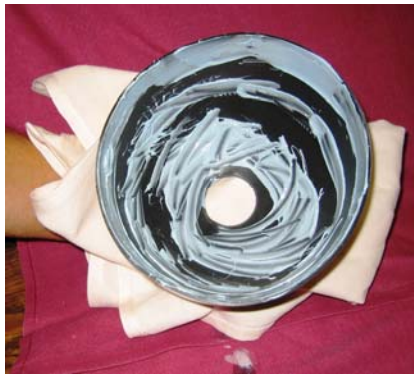
**Fig. 14**  
**Adhesive Applied**

- Quickly apply a thin coat of the mixed adhesive to the inside surface of the new end cap (see Fig. 14 on the following page).
- Carefully and quickly hold the outside of the end cap the place over the dome (see Fig. 15 on the following page).
- Position the end cap in line with the edge of the 2 in (50 mm) masking tape.
- Press firmly with both hands.
- Remove as much trapped air pockets as possible.
- Remove masking tape and excess flash.
- Allow end cap to dry for a minimum of 2 hours before placing the cylinder back in service.
